F-1-164

Moreland; Lamar-White Farmstead
Adamstown vicinity
Private

Maryland Historical Trust State Historic Sites Inventory Form

historic Moreland (preferred); Lamar-White Farmstead

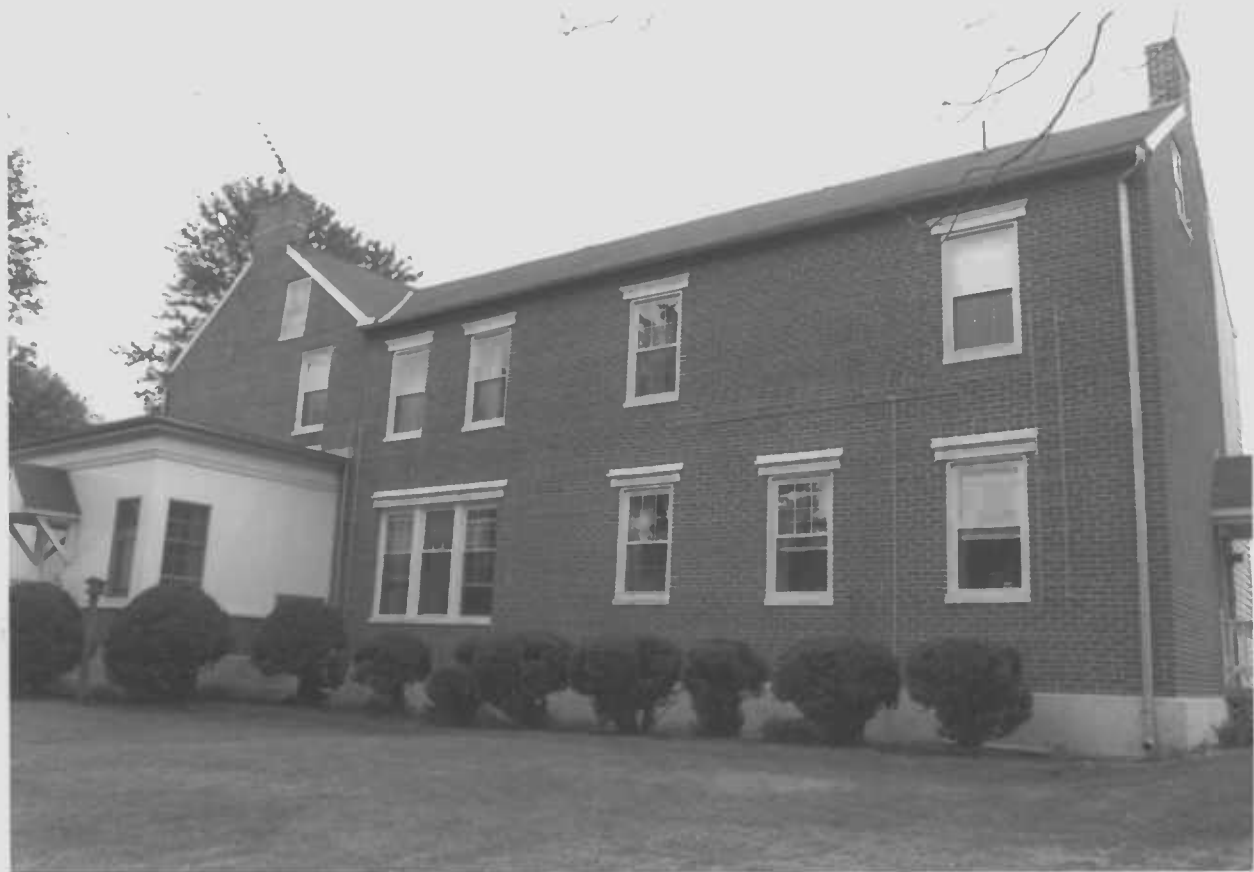
214

The dwelling has 8:1 American bond walls which have been sandblasted. The east elevation has five bays with a center entrance and a modern entry porch. The gable roof is covered with composition material, replacing the original slate roofing, and interior chimneys rise at the north and south gable ends. The cornice is corbeled brick with a dog tooth course. The window bays have 6/6 replacement sash with molded hoods with an interlaced design. The center entrance also has this molding but the fanlighted door surround appears to be an early to mid-20th century Colonial Revival replacement of the original doorway. The usual Renaissance Revival treatment, the style suggested by the window hoods, would have more likely had a large rectangular transom. The sidelights contain clear glass with zinc comes, which also appear to be of the same date as the Colonial Revival doorway. The entry porch has a brick base, a 1980's replacement, and the roof supports are grouped square posts. The gable roof has a plain flush board pediment. The entry porch is also a later replacement; evidence on the brick of an earlier porch may have been removed with the sandblasting done in about 1983. The north elevation has the one-story sun porch which was enclosed in the early 1990's. A projecting door hood is located over the exterior door from this porch. According to Mrs. Elwood Hipkins, one of the current owners, the porch also had a roof deck accessed through a door on the second floor. The door, converted from a window in the early 1950's, has been returned to a window. The rear wing of the house is considerably longer than is usually seen in the familiar L-shaped plan. A group of three windows, also a 1950's alteration, is located in the section nearest the main part of the house. The south elevation of the wing has an enclosure of the original integral two-story porch. The enclosure took place in the 1950's alteration, while the siding is a recent addition. The exterior is covered with vinyl siding and two similar entry porches are located on the south and on the west end of the wing. The south elevation of the main part of the house is abutted by the one-story brick garage added about 1950.

North elevation

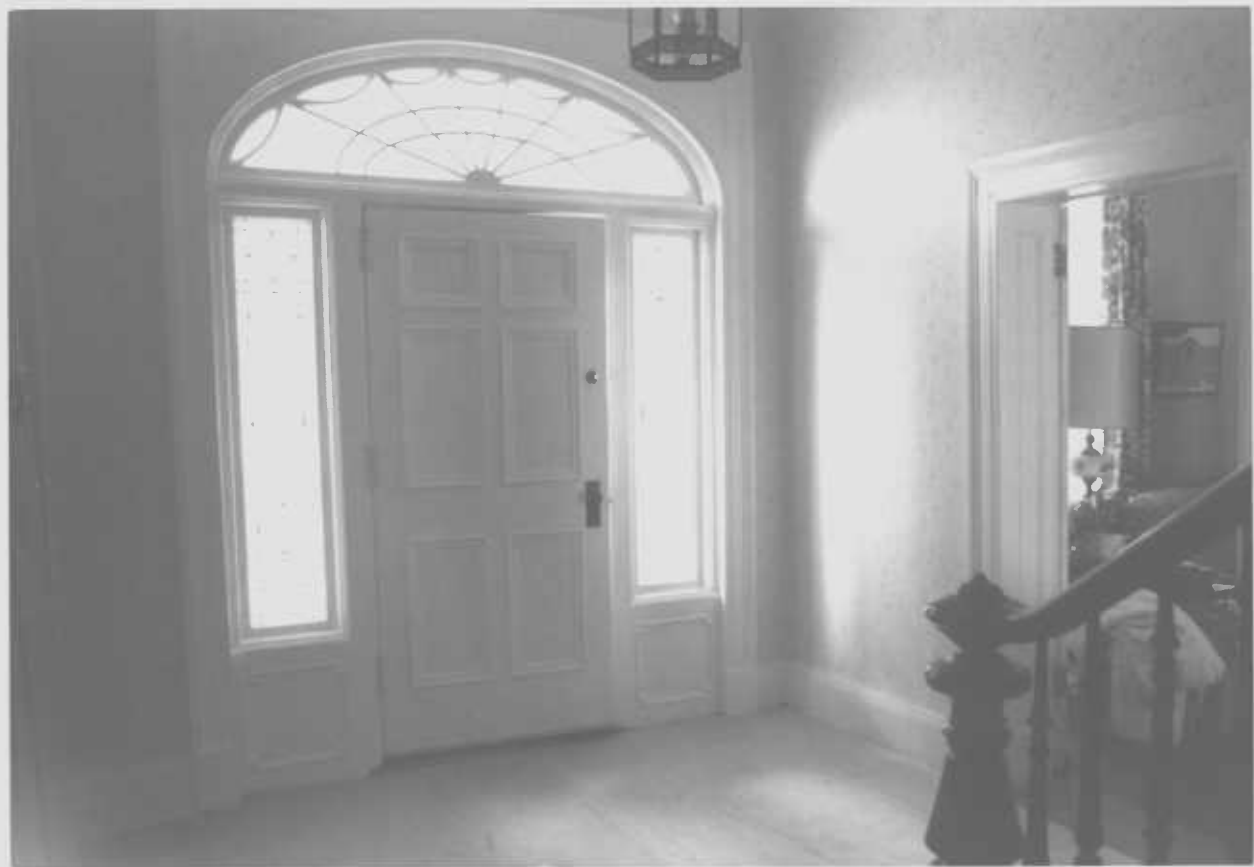
8/9

Over the main entrance on the principal facade is a one-story, one-bay wide portico supported by paired Doric columns and pilasters. This portico, like the window and door heads on the house, are unusually elaborate and may possibly be a 20th century addition, perhaps done at the same time as the garage and porch wings which were designed to blend with the house.

Main entrance, interior view

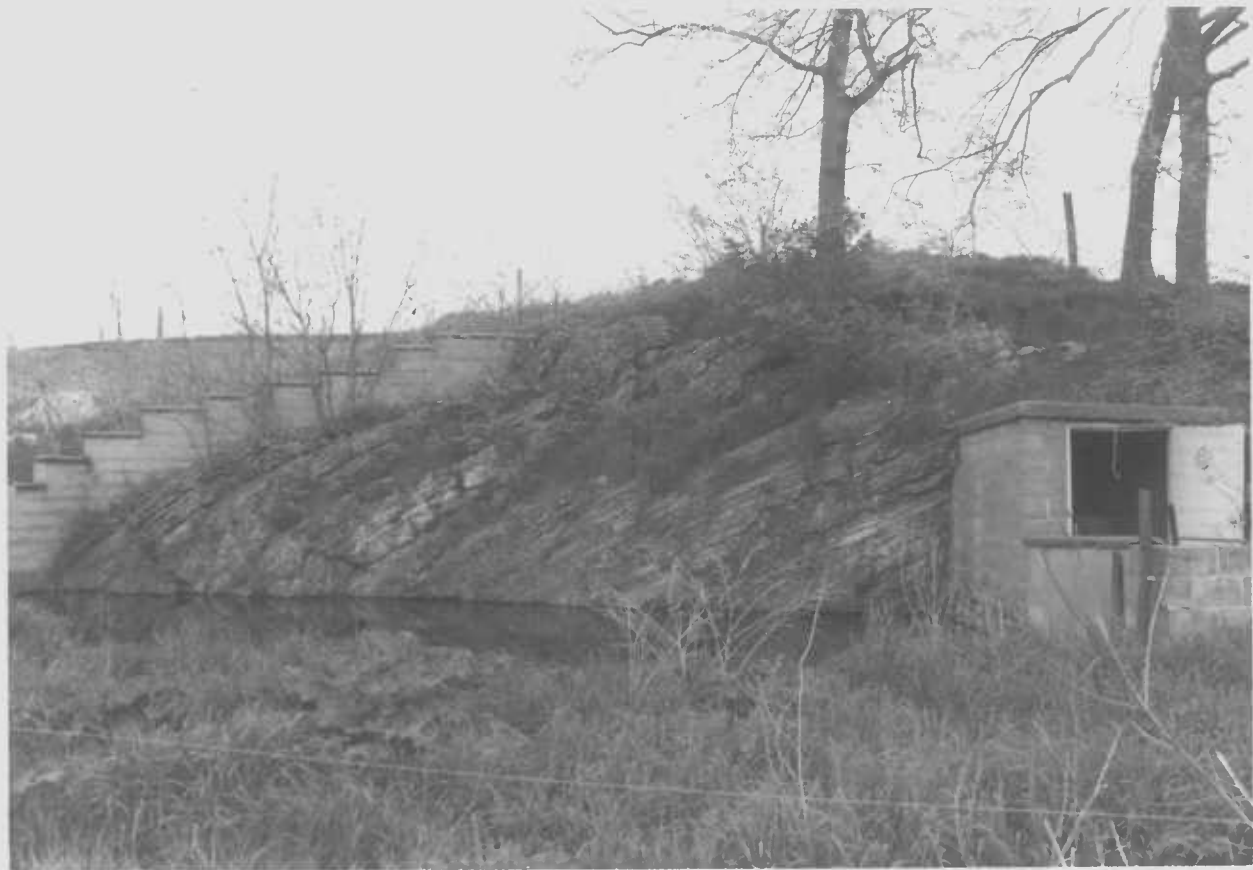
7/9

Big Spring: The natural spring is located near the present milking barn and the tenant house. It is at the base of an exposed uplifted rock face, where concrete block retaining walls and a pump house have been built around its. The spring keeps a large pool constantly level and supplies the dairy barn, while the dwelling currently has a separate well, although the spring was historically the source of all water on the farmstead.

"Big Spring" view from west

The Big Spring is one of several springs in the Adamstown Region located on farms named after their individual character. These were the Three Springs on Buckeystown Pike east of Moreland, the Boiling Spring, possibly located just west of Ballenger Creek Pike near the Manor Woods Road intersection, and Rocky Fountain, just northwest of Buckeystown.

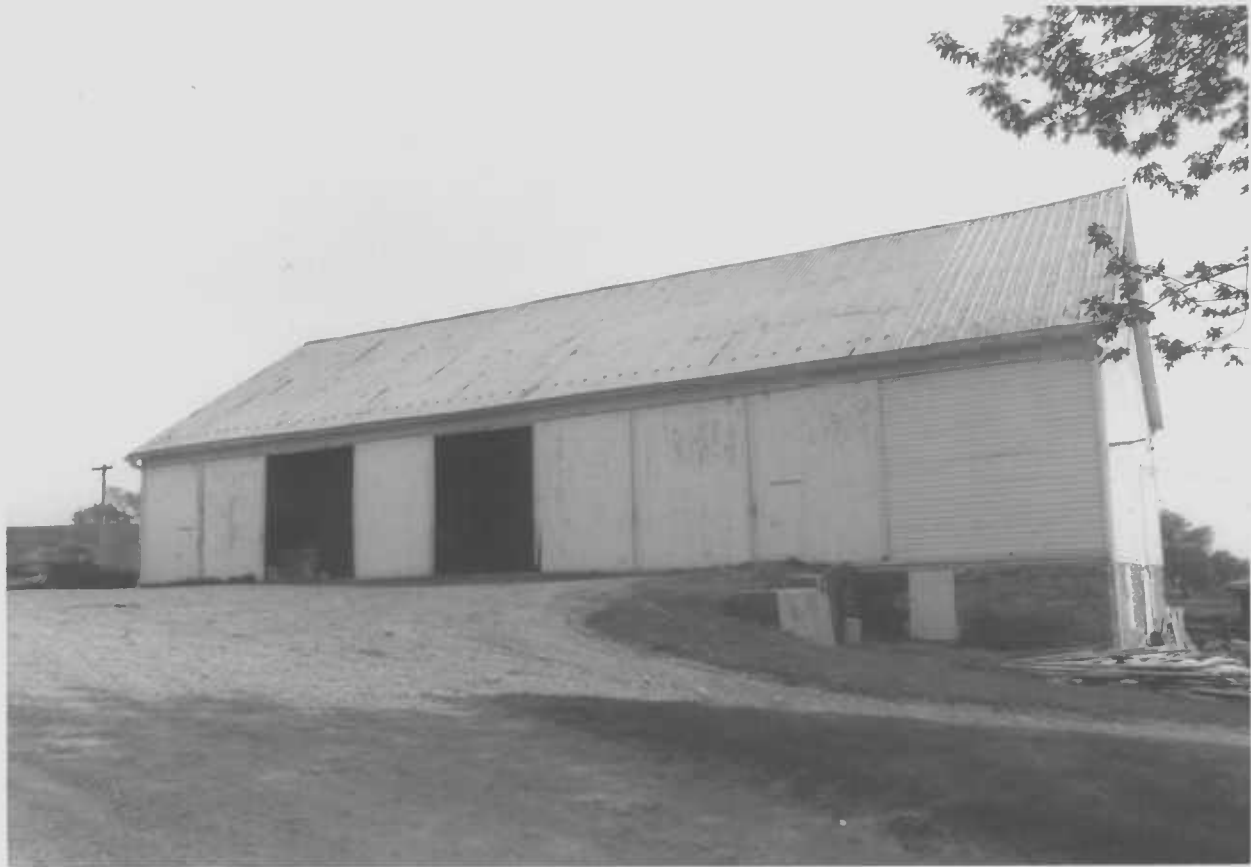
G/g

Bank barn: The bank barn also appears to have been built about 1900 and has german siding and a corrugated metal roof. Three sets of sliding doors are located on the north elevation and the east and west elevations have twin louvred vents.

Bank barn, north elevation

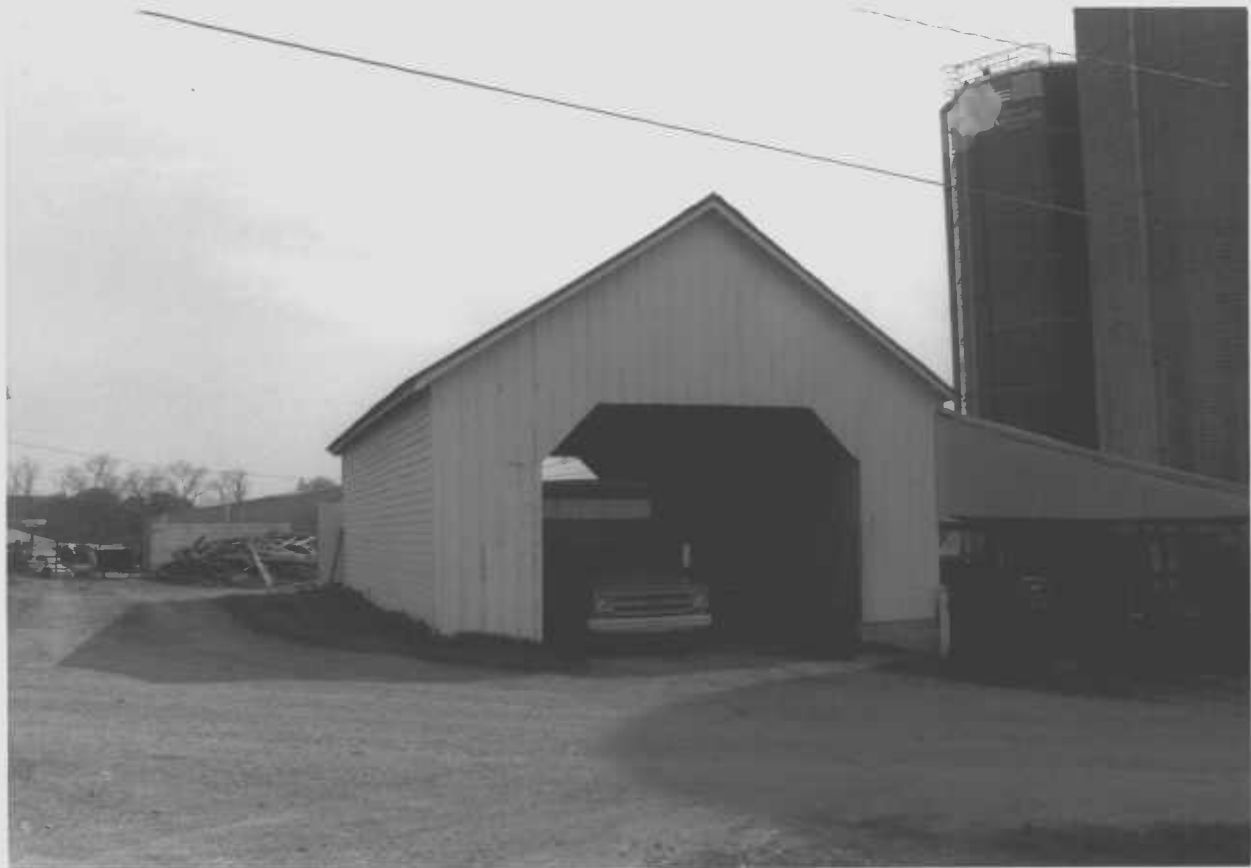
7.1

Wagon shed/corn crib: The frame wagon shed with flanking corn cribs was built about 1890-1900, based on its materials and construction. It is located near the center of the outbuilding group and its drive-through is oriented north-south. The north elevation has board and batten siding and the side elevations are horizontal vented boards. The roof is covered with corrugated metal.

Wagon shed, cor. on a north elevation
